INDIVIDUAL PROPERTY/DISTRICT
MARYLAND HISTORICAL TRUST
INTERNAL NR-ELIGIBILITY REVIEW FORM

Property/District Name: Randallstown Elementary School Survey Number: BA-2558
Project: Enlargement Agency: PSCP
Site visit by MHT Staff: X no yes Name Date

Maryland Historical Trust Maryland Inventory of Historic Properties Form

1. Name of Property Randallstown Elementary School

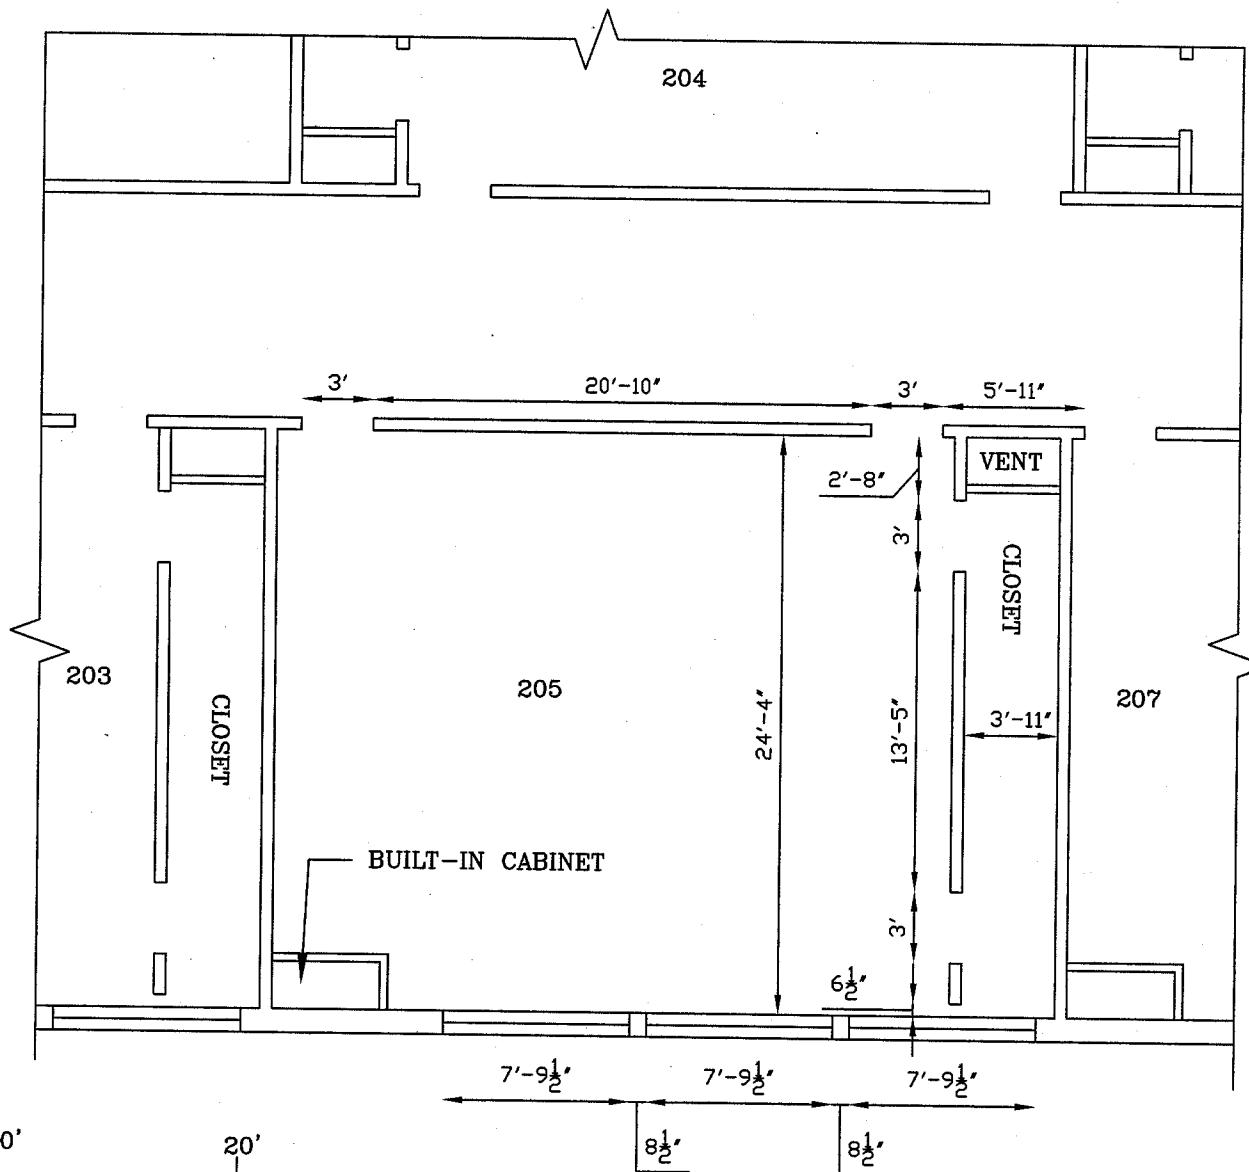
RANDALLSTOWN ELEMENTARY SCHOOL (BA-2558)
 TYPICAL CLASSROOM
 9013 LIBERTY ROAD
 RANDALLSTOWN MARYLAND

Inside, the classrooms appear uniform in size and shape. The 1938 addition replicates the 1926 rooms nearly exactly. Each room is approximately 23 feet wide and ranges from 28 to 33 feet in length. They all possess blackboards or bulletin boards on all sides except the window wall. They have plaster walls, acoustical tile dropped ceilings, suspended fluorescent lights, metal Venetian blinds, and 12-inch floor tiles. Each classroom has its own coatroom, located at one end, which is 23 feet long and four feet wide. The older rooms have two doors into the coatrooms, while the 1938 rooms only have one. All coatrooms have an exterior window (the sixth in the banks of six windows). They have a shelf running the length of the room with numerous coat hooks below.

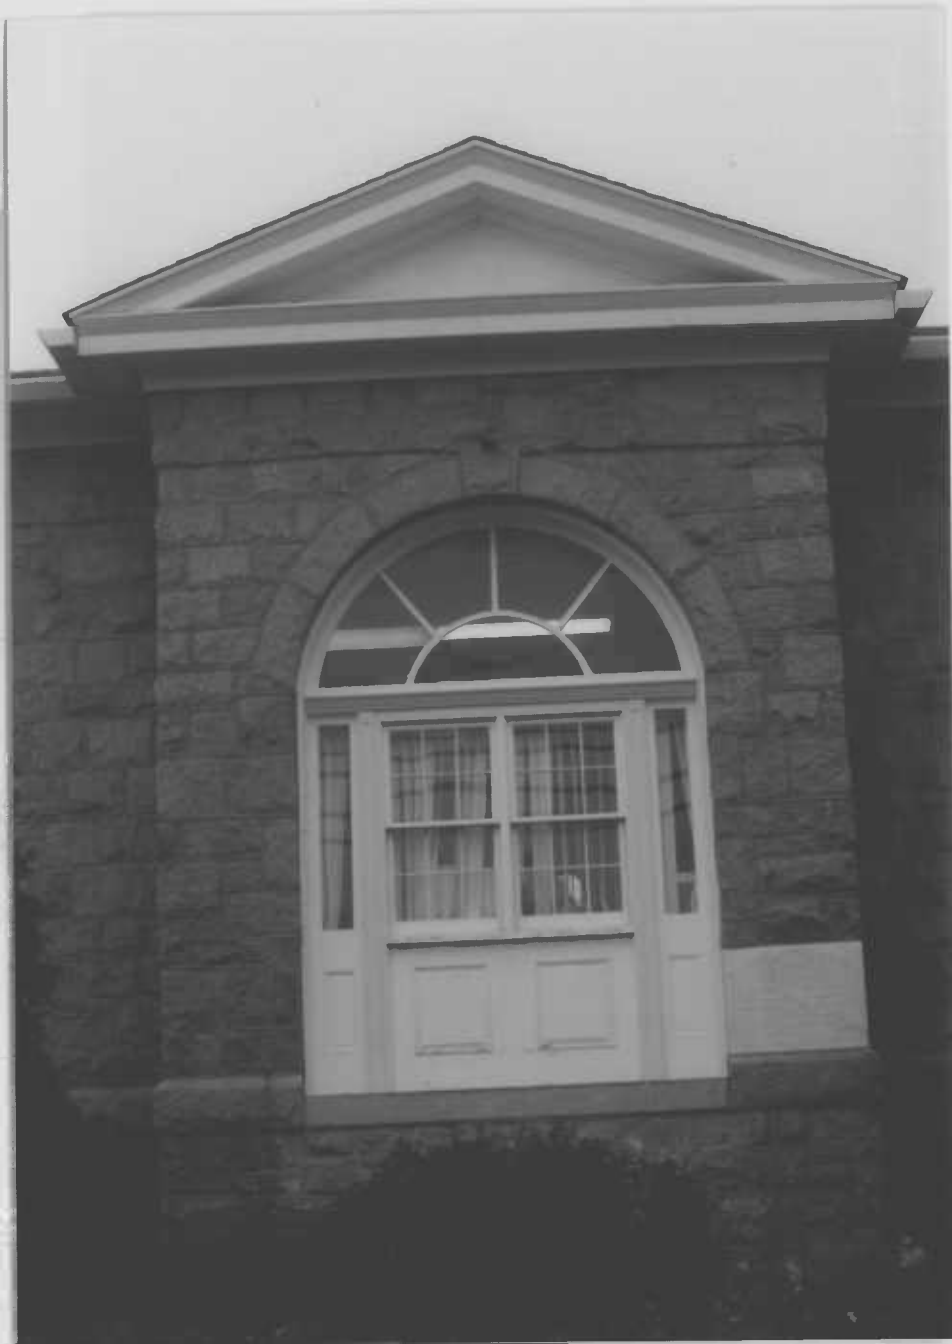
#1 of 24

20-212
L.A. School for the Deaf
Balance 20-212
1000 20-212 1000
1000 20-212
N. elevation, original 20-212
1000 20-212

The north facade of the building appears fairly uniform as both the original building and the addition were constructed of squared rough cut granite ashlar blocks arranged in irregular courses with beaded mortar. Two additional courses were added to the top of the 1908 building to bring it up to the same height as the addition. The original door was located centrally in the 1908 building within a projecting pedimented entrance. The door was flanked by multipane sidelights and topped with a 5-light semicircular fanlight. The opening now contains 6/6 vinyl sash windows above paneled wood. When the addition was put on in 1926, another entrance was added through a central set of doors further east on the north facade. The granite staircase up to the original doors was removed sometime after 1938, but the marble cornerstone paying tribute to those involved in the inception and construction of the Randallstown School is still located at the lower west corner of where the door was.

The 1908 building has triple 2/2 vinyl sash windows flanking the former entrance and three 1/1 vinyl sash basement windows on either side. Historic photos show the first floor windows as large 8/8 wood sash flanked by narrower 4/4 wood sash windows. The basement windows are vinyl 2/2 sash. The first floor windows have granite lintels and sills. A granite water table with a sloped and scored upper edge surrounds the original building. The water table forms a continuous lintel for the basement windows on the 1908 end of the north side and a sill for the auditorium's windows. On the west and east sides, it acts as a belt course.
